TRISCAN

TRISCAN AC Hoses

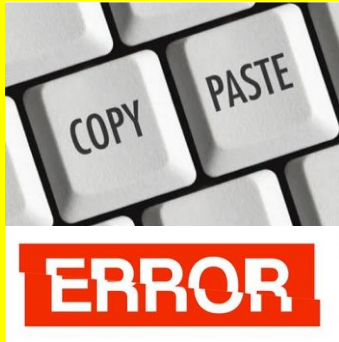
- Existing aftermarket ranges are narrow and often not developed from OE samples, but from aftermarket products.
- This fact leads to compounding mistakes on critical to quality dimensions like:
 - Bends
 - Clocking of angles on fittings
 - Poor quality hose
 - Welds
 - QA.

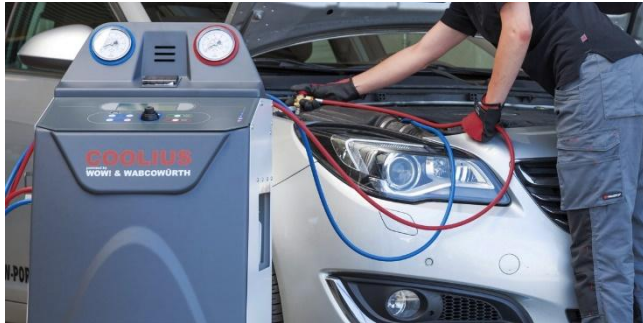
Improper consolidation

20	5Q0 820 743 C	Refrigerant line (A/C compressor > cut-off point)	1 PR:T9B,TK8, TL1,TM5,TP1+ KK1

(20)	5Q0 816 743 E	Refrigerant line (A/C compressor > cut-off point)	1 PR:T3Q,TA8, TI6,TP6,TT6+ KK3

R-134A Refrigerant

R-1234YF Refrigerant

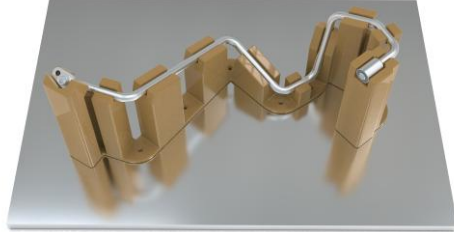
Product quality

- Every item is developed based on 3D scanned OE samples.
- True to OE in terms of hoses, pipes, fittings, brackets, angles and bends.
- Assembled using fixtures.
- In-house production of all components and hose.
- All pipe fittings are brazed by robot.
- Leakage testing of each individual pipe and fitting.
- Leakage testing of assembled hose with nitrogen.
- Produced by one of the largest OE manufacturers of A/C hoses in the world.

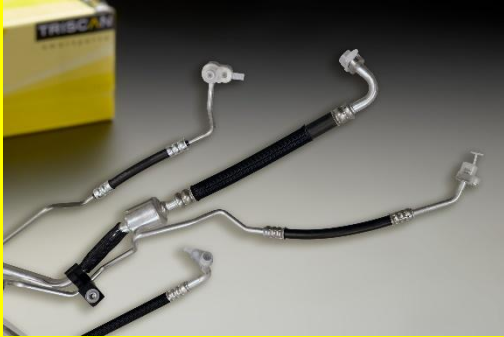
Product quality – Hose testing

- Volumetric expansion
- Pulse test (300,000 cycles)
- Burst test
- Vibration test
- Tensile test
- Aging test
- Permeability testing <5 gram pr. meter of hose pr year
